INTERSECTION SUGGESTIONS FOR RT TURN PAVEMENT INSUFFICIENCY

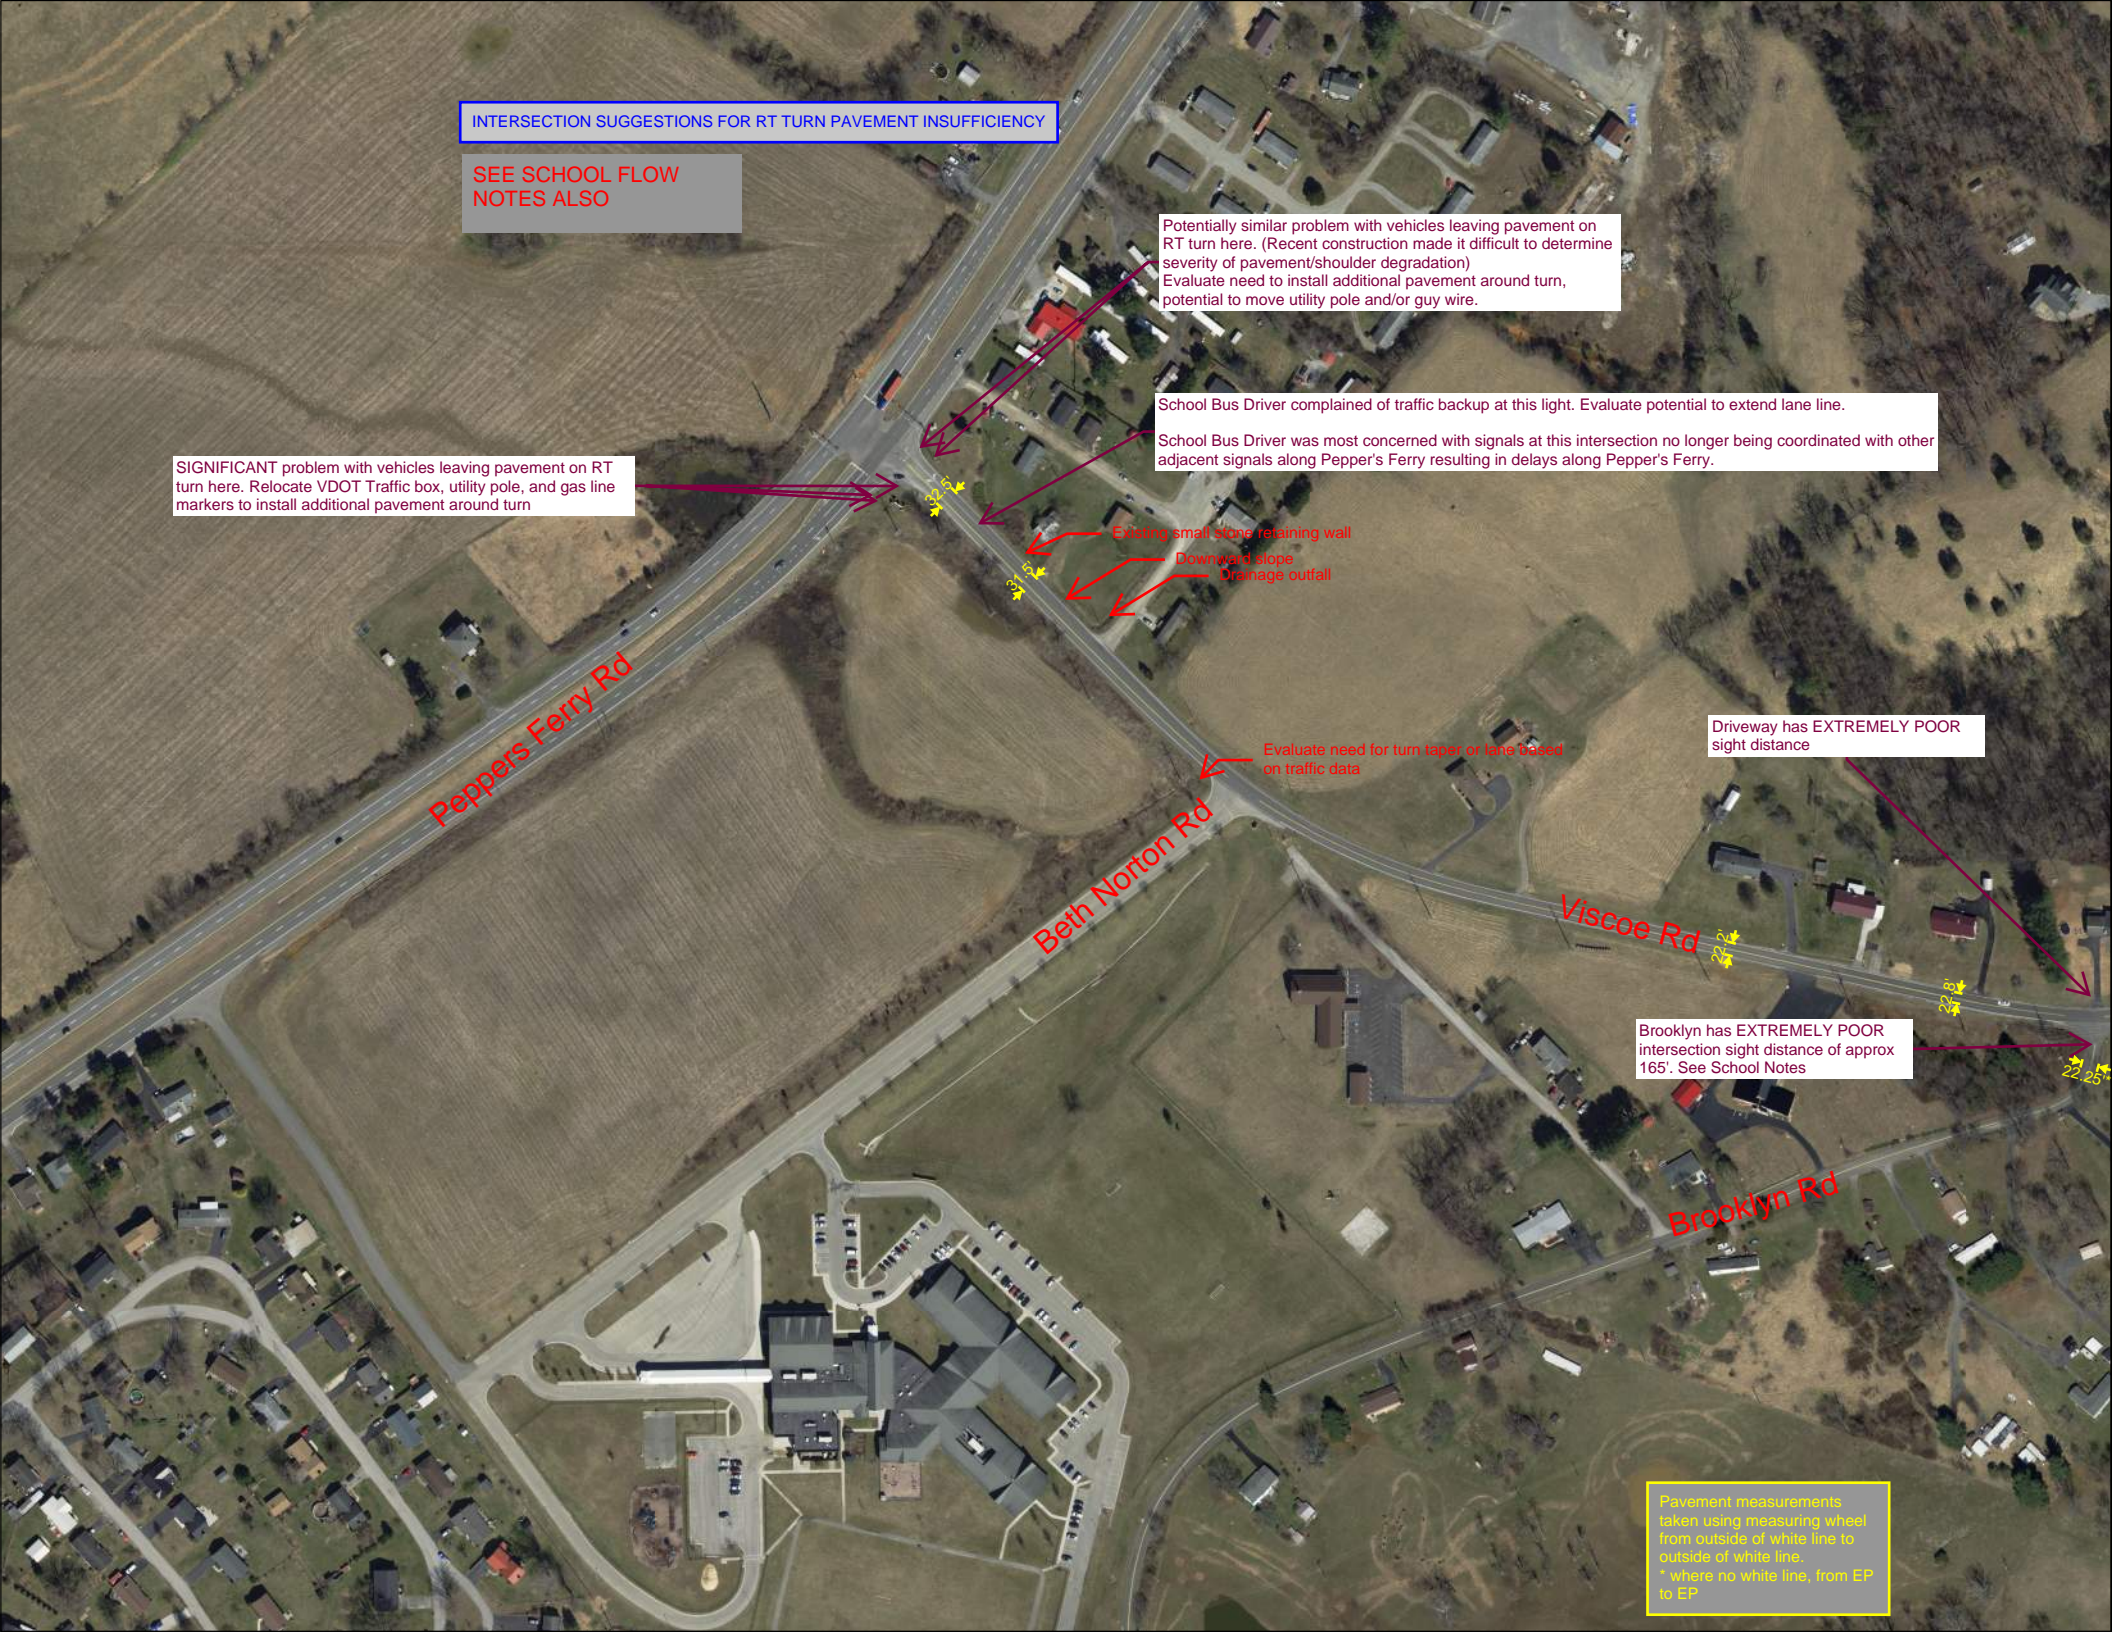
Potentially similar problem with vehicles leaving pavement on RT turn here. (Recent construction made it difficult to determine severity of pavement/shoulder degradation) Evaluate need to install additional pavement around turn, potential to move utility pole and/or guy wire.

School Bus Driver complained of traffic backup at this light. Evaluate potential to extend lane line.

School Bus Driver was most concerned with signals at this intersection no longer being coordinated with other adjacent signals along Pepper's Ferry resulting in delays along Pepper's Ferry.

SIGNIFICANT problem with vehicles leaving pavement on RT turn here. Relocate VDOT Traffic box, utility pole, and gas line markers to install additional pavement around turn

Driveway has EXTREMELY POOR sight distance

Brooklyn has EXTREMELY POOR intersection sight distance of approx 165'. See School Notes

Evaluate need for turn taper or lane based on traffic data

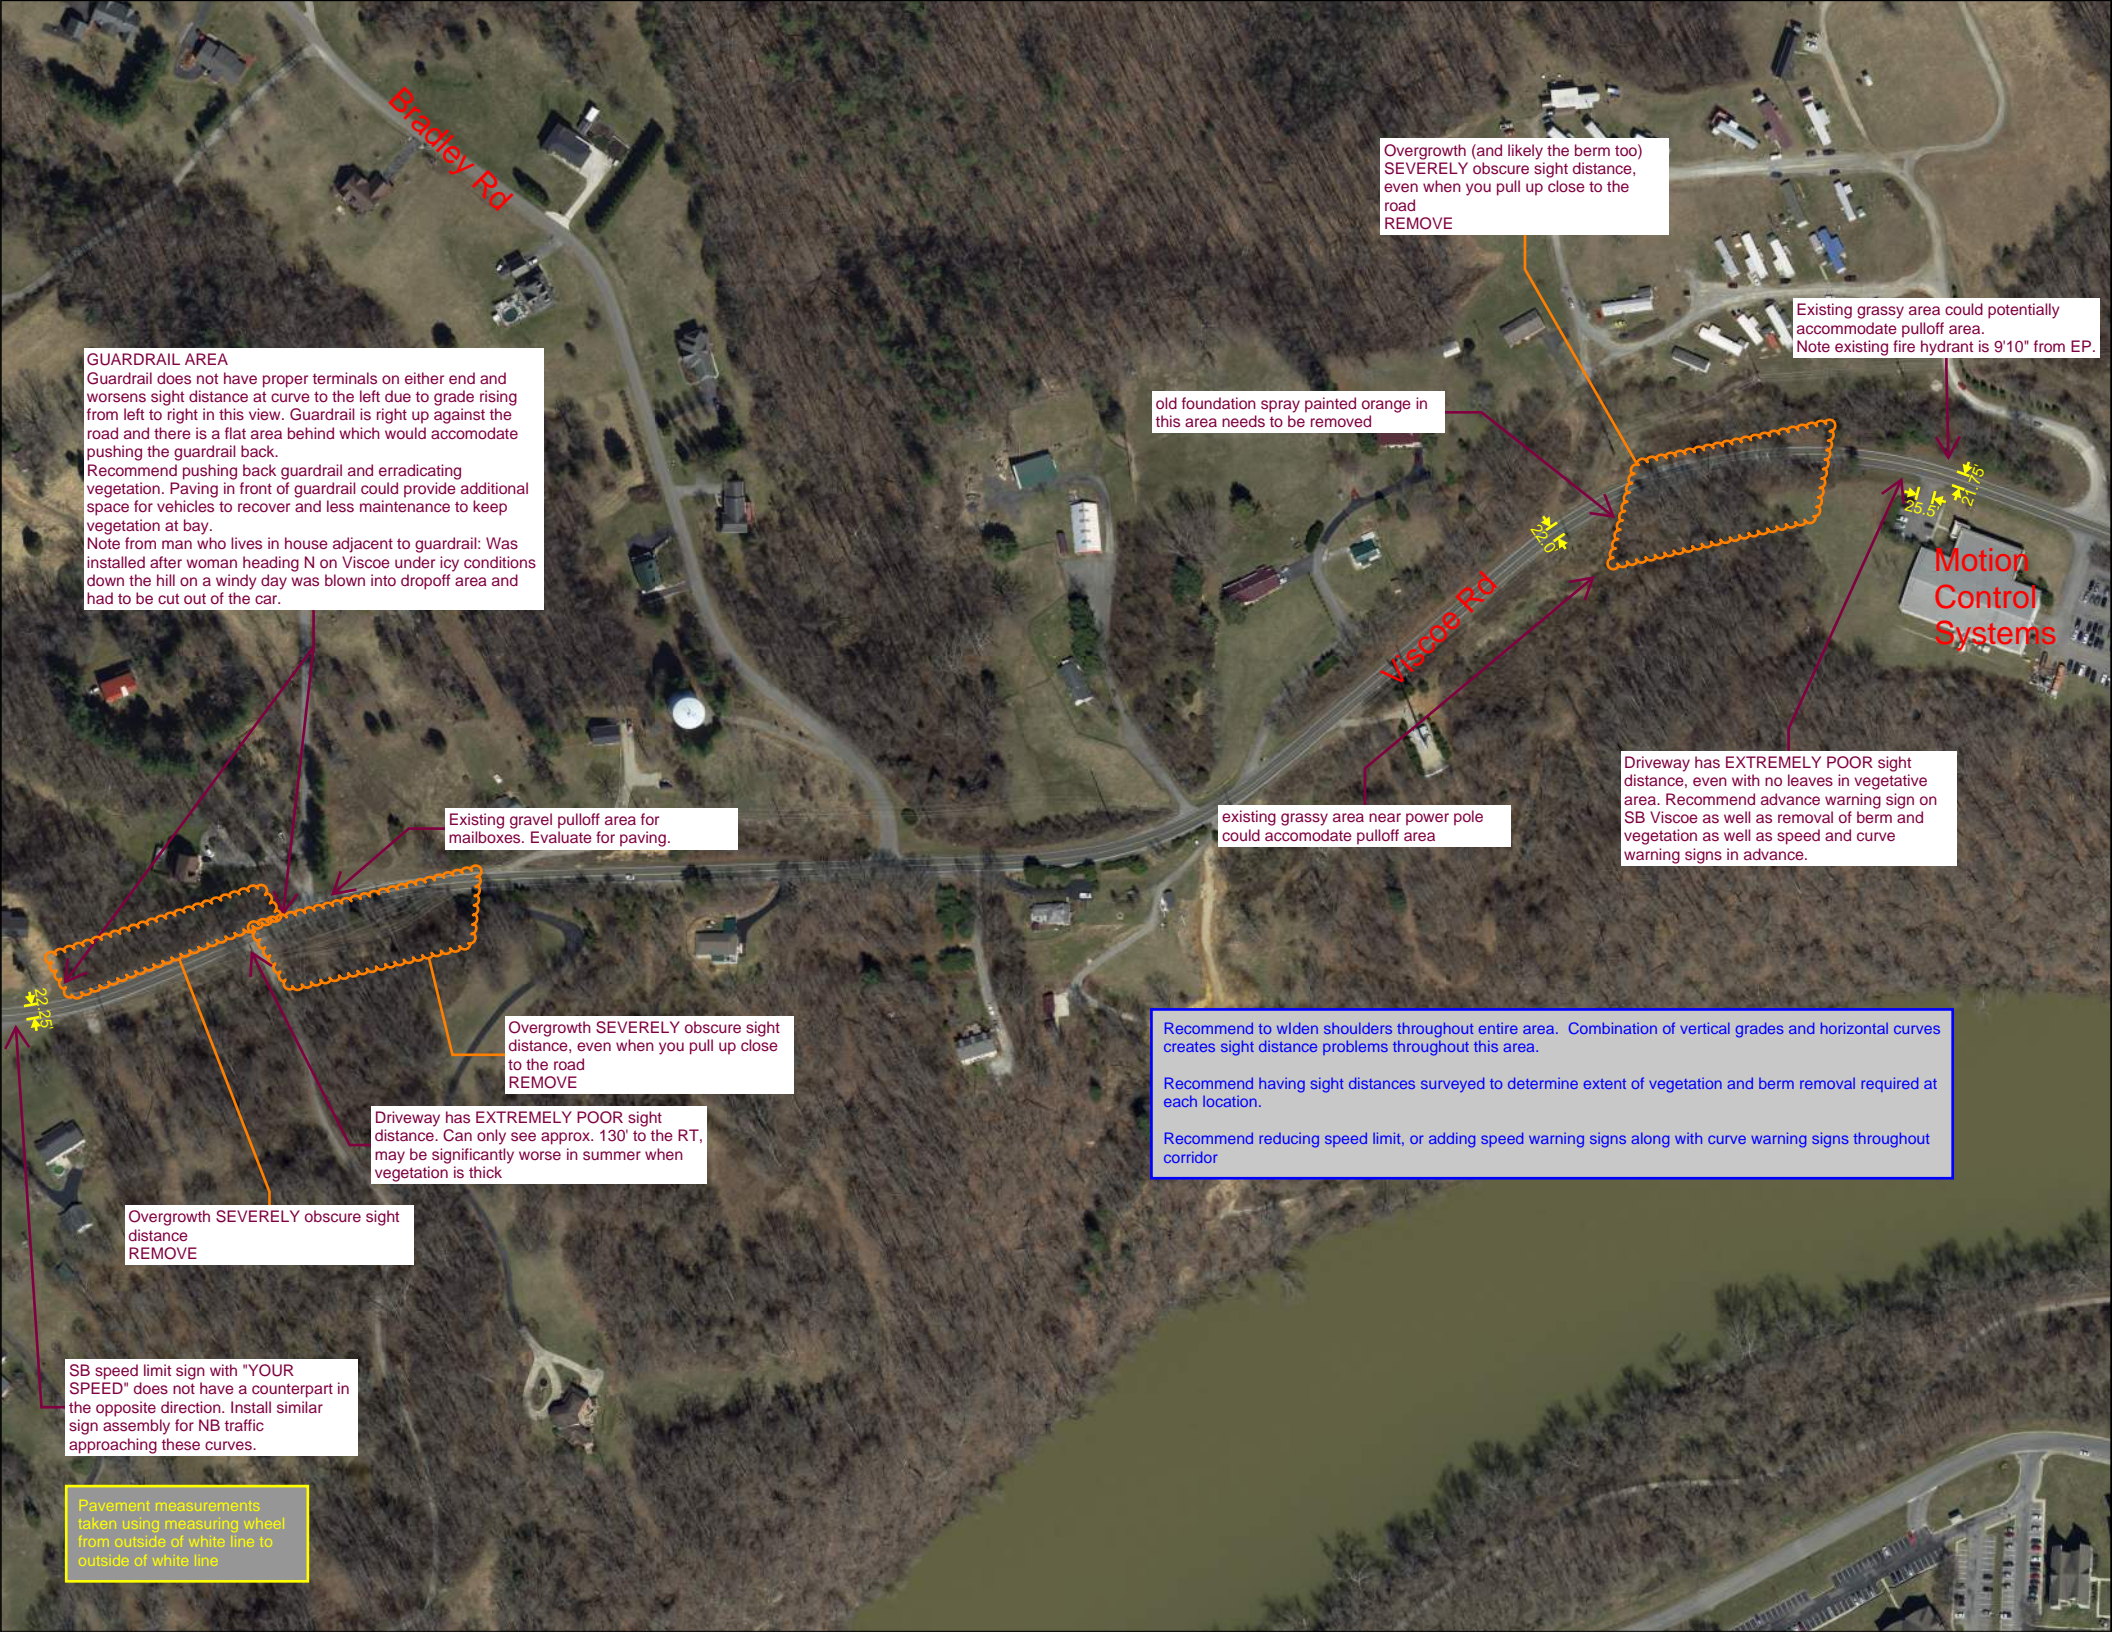
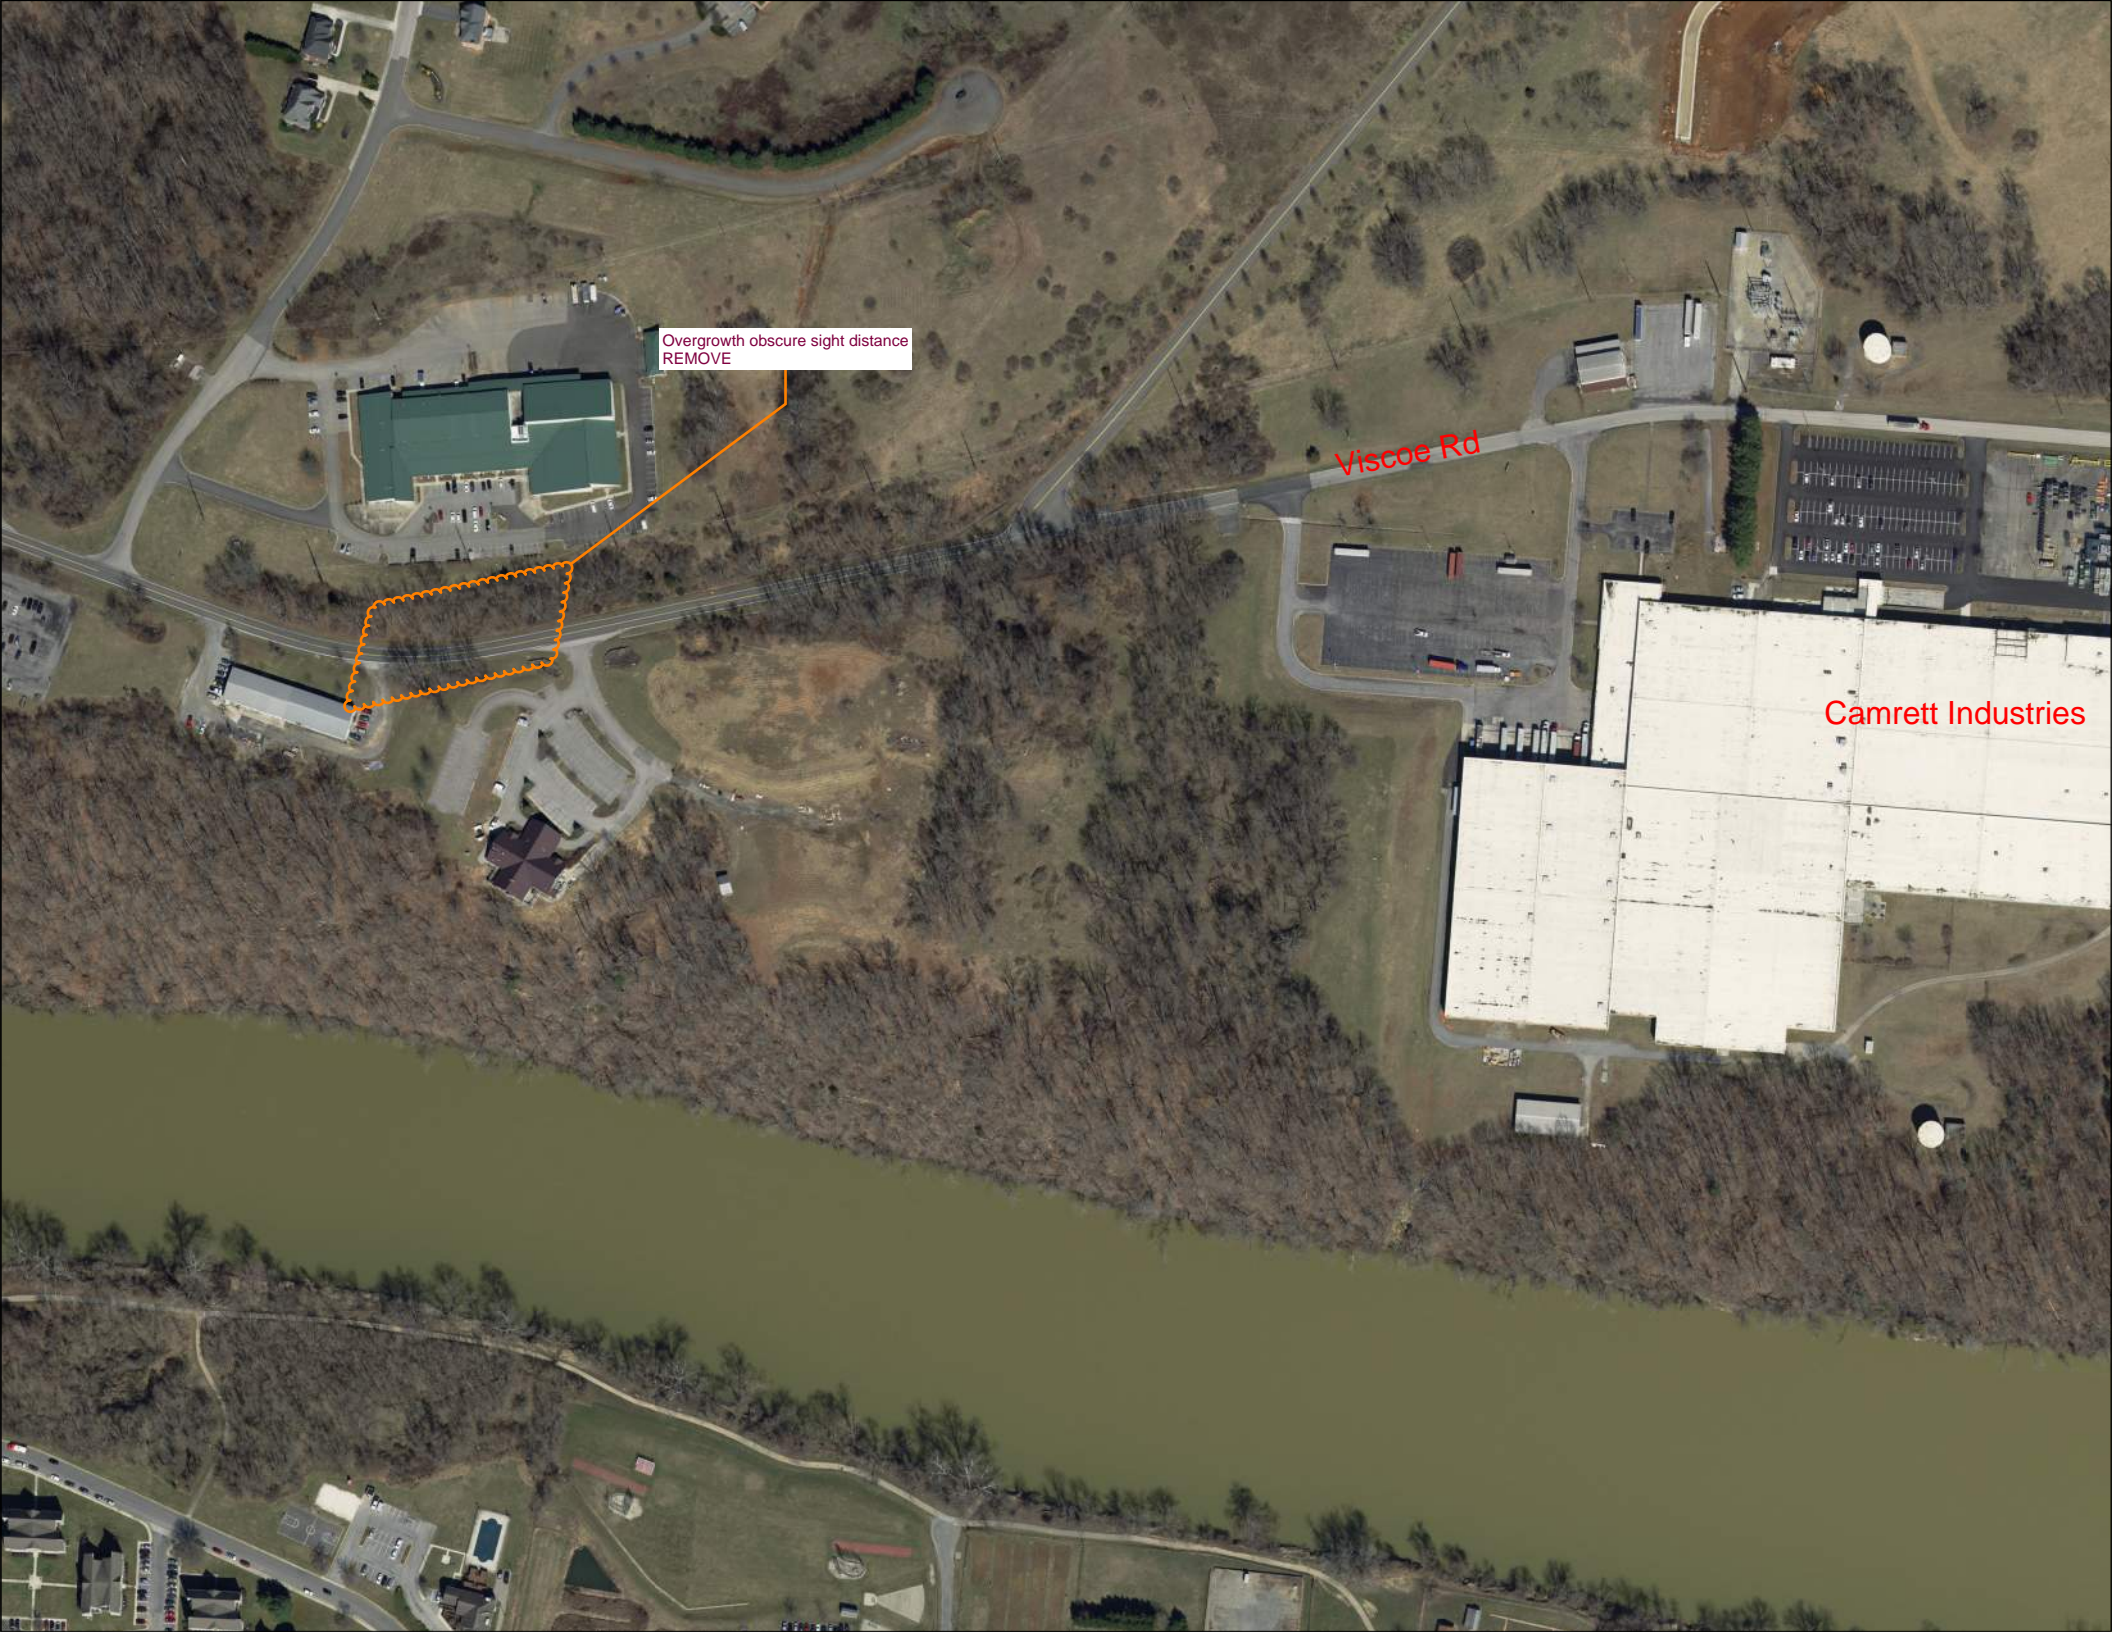
Overgrowth (and likely the berm too) SEVERELY obscure sight distance, even when you pull up close to the road REMOVE

**GUARDRAIL AREA**  
Guardrail does not have proper terminals on either end and worsens sight distance at curve to the left due to grade rising from left to right in this view. Guardrail is right up against the road and there is a flat area behind which would accommodate pushing the guardrail back.  
Recommend pushing back guardrail and erradicating vegetation. Paving in front of guardrail could provide additional space for vehicles to recover and less maintenance to keep vegetation at bay.  
Note from man who lives in house adjacent to guardrail: Was installed after woman heading N on Viscoe under icy conditions down the hill on a windy day was blown into dropoff area and had to be cut out of the car.

Driveway has EXTREMELY POOR sight distance, even with no leaves in vegetative area. Recommend advance warning sign on SB Viscoe as well as removal of berm and vegetation as well as speed and curve warning signs in advance.

Recommend to wlden shoulders throughout entire area. Combination of vertical grades and horizontal curves creates sight distance problems throughout this area.  
Recommend having sight distances surveyed to determine extent of vegetation and berm removal required at each location.  
Recommend reducing speed limit, or adding speed warning signs along with curve warning signs throughout corridor

Overgrowth SEVERELY obscure sight distance, even when you pull up close to the road REMOVE

Driveway has EXTREMELY POOR sight distance. Can only see approx. 130' to the RT, may be significantly worse in summer when vegetation is thick

Overgrowth SEVERELY obscure sight distance REMOVE

SB speed limit sign with "YOUR SPEED" does not have a counterpart in the opposite direction. Install similar sign assembly for NB traffic approaching these curves.

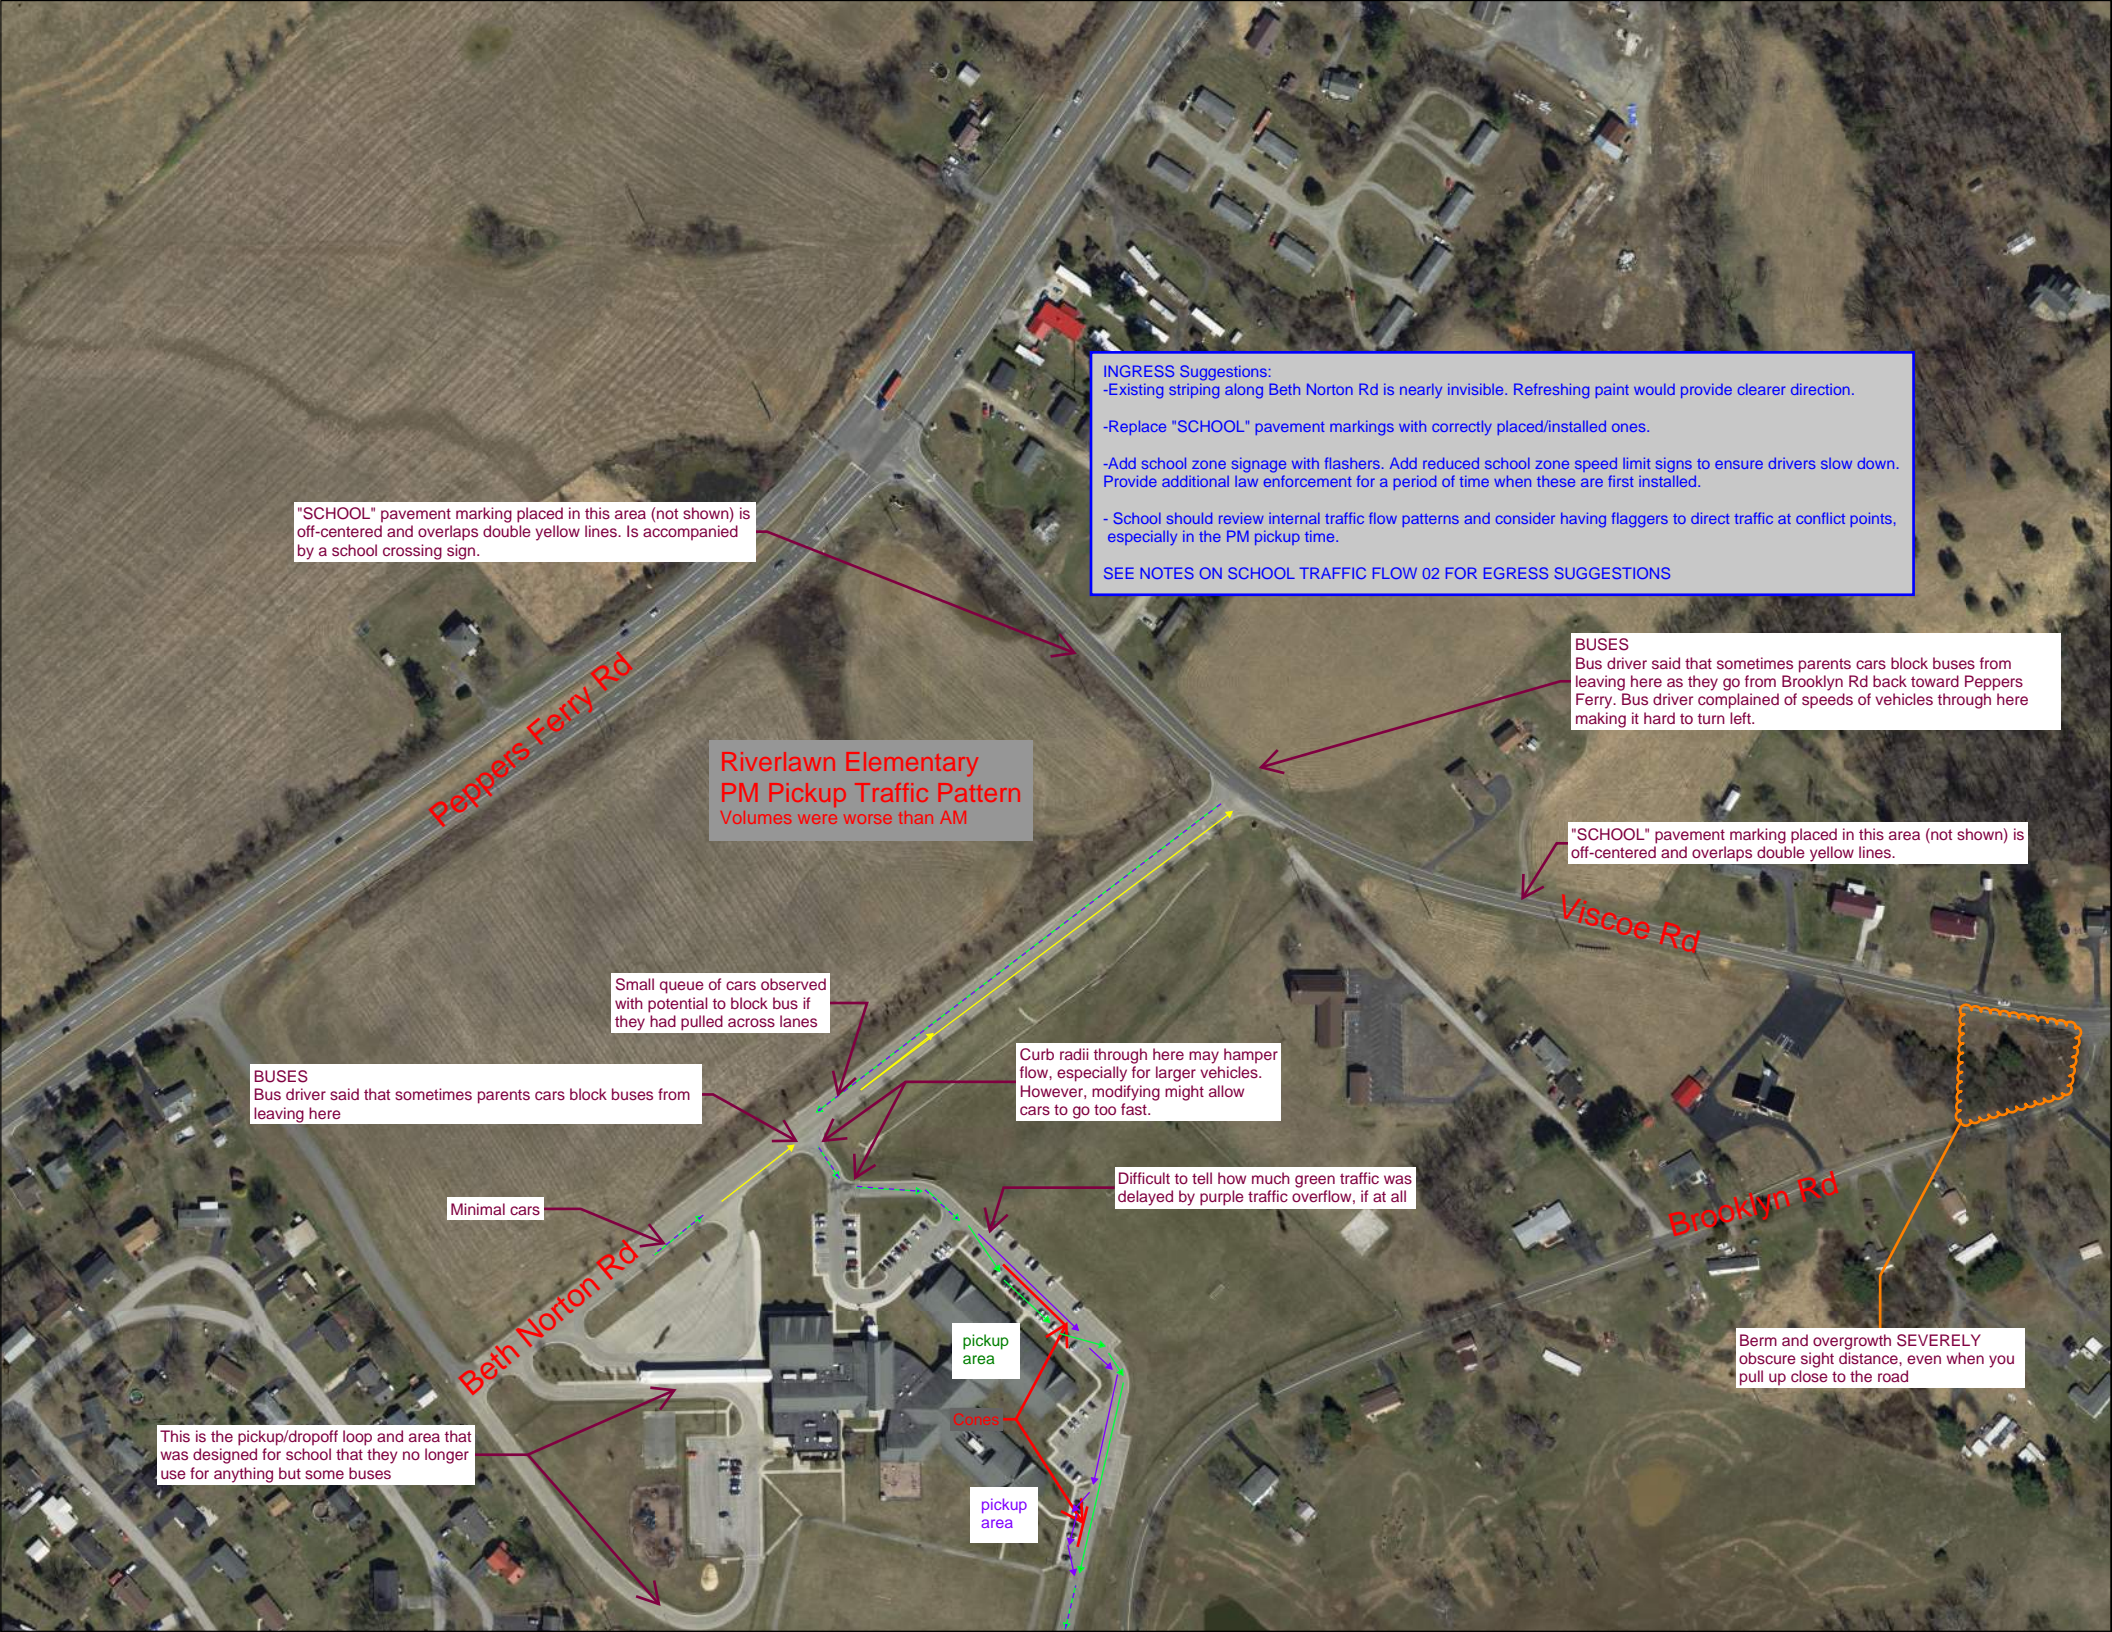
Riverlawn Elementary  
AM Dropoff/ PM Pickup  
Traffic Pattern  
PM Volumes were worse than AM

"SCHOOL" pavement marking placed in this area (not shown) is off-centered and overlaps double yellow lines. Is accompanied by a school crossing sign.

**BUSES**  
Bus driver said that sometimes parents cars block buses from leaving here as they go from Brooklyn Rd back toward Peppers Ferry. Bus driver complained of speeds of vehicles through here making it hard to turn left.

"SCHOOL" pavement marking placed in this area (not shown) is off-centered and overlaps double yellow lines.

Small queue of cars observed with potential to block bus if they had pulled across lanes

Curb radii through here may hamper flow, especially for larger vehicles. However, modifying might allow cars to go too fast.

Difficult to tell how much green traffic was delayed by purple traffic overflow, if at all

Berm and overgrowth SEVERELY obscure sight distance, even when you pull up close to the road

Stop sign located too far back  
No stop bar  
Observed cars stopping twice  
(at sign and at edge of  
Brooklyn Rd)

Portable/temporary sign with sand or  
water base blocks traffic trying to enter  
from Brooklyn Rd; Reads:  
DO NOT ENTER  
ONE WAY TRAFFIC

Bamboo SEVERELY obscures sight  
distance, even when you pull up close  
to the road

**INGRESS Suggestions:**  
-Existing striping along Beth Norton Rd is nearly invisible. Refreshing paint would provide clearer direction.  
-Replace "SCHOOL" pavement markings with correctly placed/installed ones.  
-Add school zone signage with flashers. Add reduced school zone speed limit signs to ensure drivers slow down. Provide additional law enforcement for a period of time when these are first installed.  
- School should review internal traffic flow patterns and consider having flaggers to direct traffic at conflict points, especially in the PM pickup time.  
**SEE NOTES ON SCHOOL TRAFFIC FLOW 02 FOR EGRESS SUGGESTIONS**

EGRESS Suggestions:  
- Remove cluster of Bamboo that obscures sight distance.  
- Push stop sign up to correct distance from Brooklyn Rd.  
- Add a supplementary stop sign on the back of the portable/temporary do not enter sign they use.  
- Add a stop bar  
- Add SCHOOL pavement markings at correct locations  
- Add school zone signage with flashers. Add reduced school zone speed limit signs to ensure drivers slow down. Provide additional law enforcement for a period of time when these are first installed.  
SEE NOTES ON SCHOOL TRAFFIC FLOW 01 FOR INGRESS SUGGESTIONS
